Appendix K: Ketchikan

Guide to direct fieldwork for cataloging anadromous water bodies in Southeast Alaska

KETCHIKAN SURVEYS

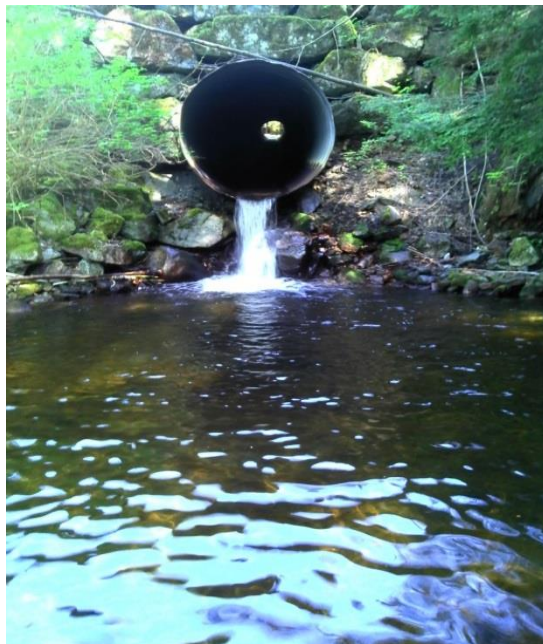
Figure 1.–Hoadley Creek barrier culvert.

Findings: We surveyed this stream using a minnow trap and a GPS (Table 1). We ended the survey at a perched culvert that had a very deep and large pool at base (Figure 1). The culvert is long enough to impede fish passage. The stream's actual route differs significantly from the currently cataloged route.

Recommendations: Update this stream's course to reflect the field verified route (Figure 2).

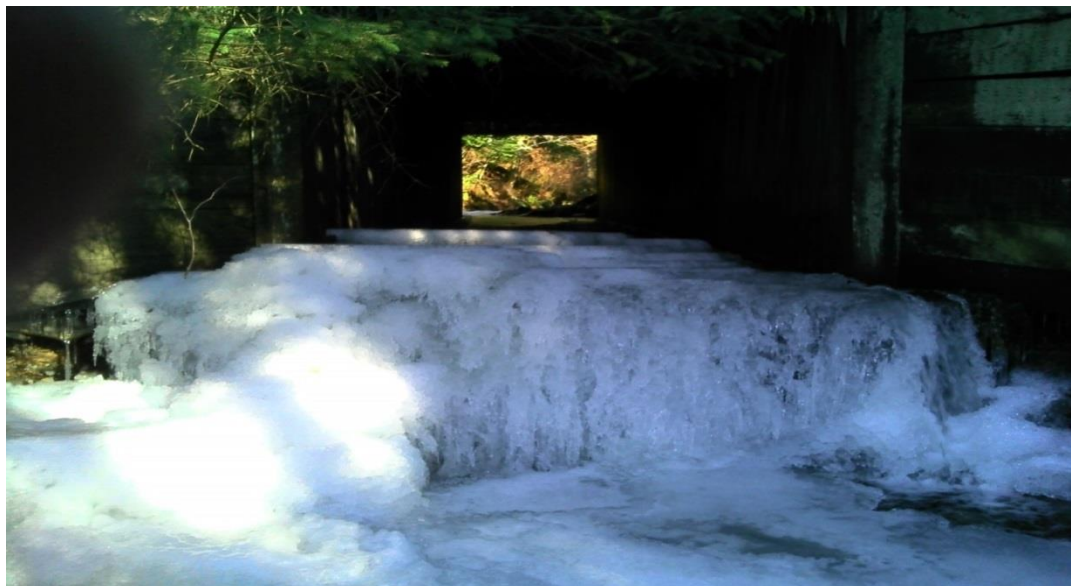
Figure 1.–101-47-10300 culvert barrier in the winter.

Findings: We surveyed this stream using a backpack electrofisher, minnow traps and a GPS (Table 1). This stream has a box culvert barrier to upstream migration; there is no jump pool (Figure 1). I called Mark Eisenman with the culvert project in Anchorage; my suspicions were confirmed that fish cannot pass.

Recommendations: Adjust the upper limit of anadromy to reflect the field verified route (Figure 2).

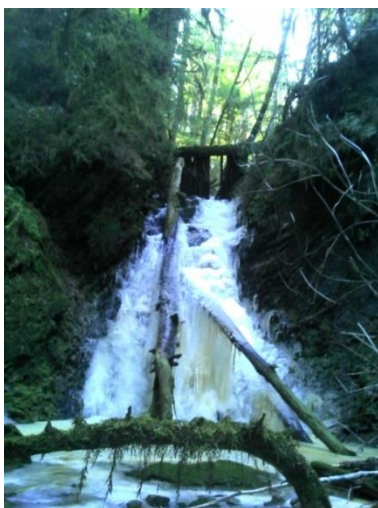
Figure 1.—Barrier falls on 1st Waterfall Creek.

Waypoint	Latitude	Longitude	Notes	Sample Effort	Sample Results
39	55.4732	-131.7892	Stream forks, tracking main flow.		
40	55.4724	-131.7882	Culvert outlet that goes under tongass ave, has good pool at base but is perched 2' and there are several pipes in and around this area.		
41	55.4723	-131.7880	Culvert inlets, pipes enter river left of culvert.		
42	55.4709	-131.7855	30' barrier falls here. Looks like there is an old dam at the to where the channel narrows. Wood culvert also at the base of the falls.

Recommendations: Please update this stream's route to reflect the field verified route, and add COr to the AWC database (Figure 2).
